Streatham Hill Theatre

Existing Site Condition Report

Site visit
18th February 2019

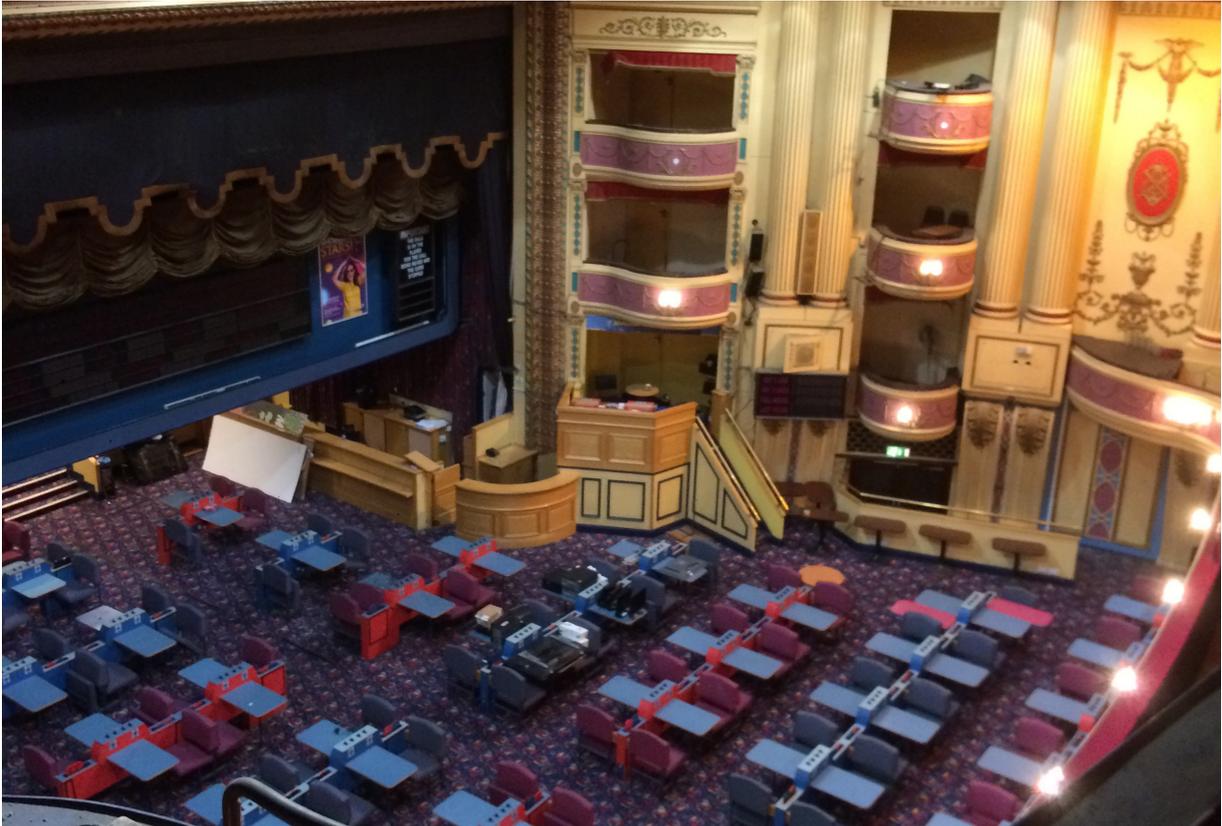
1. Main auditorium space. Damp conditions with peeling plaster and paintwork. Bingo has ceased in the central area which is built on a raised floor. The original stalls floor sits below this and is currently damp and decaying from a poorly ventilated space.

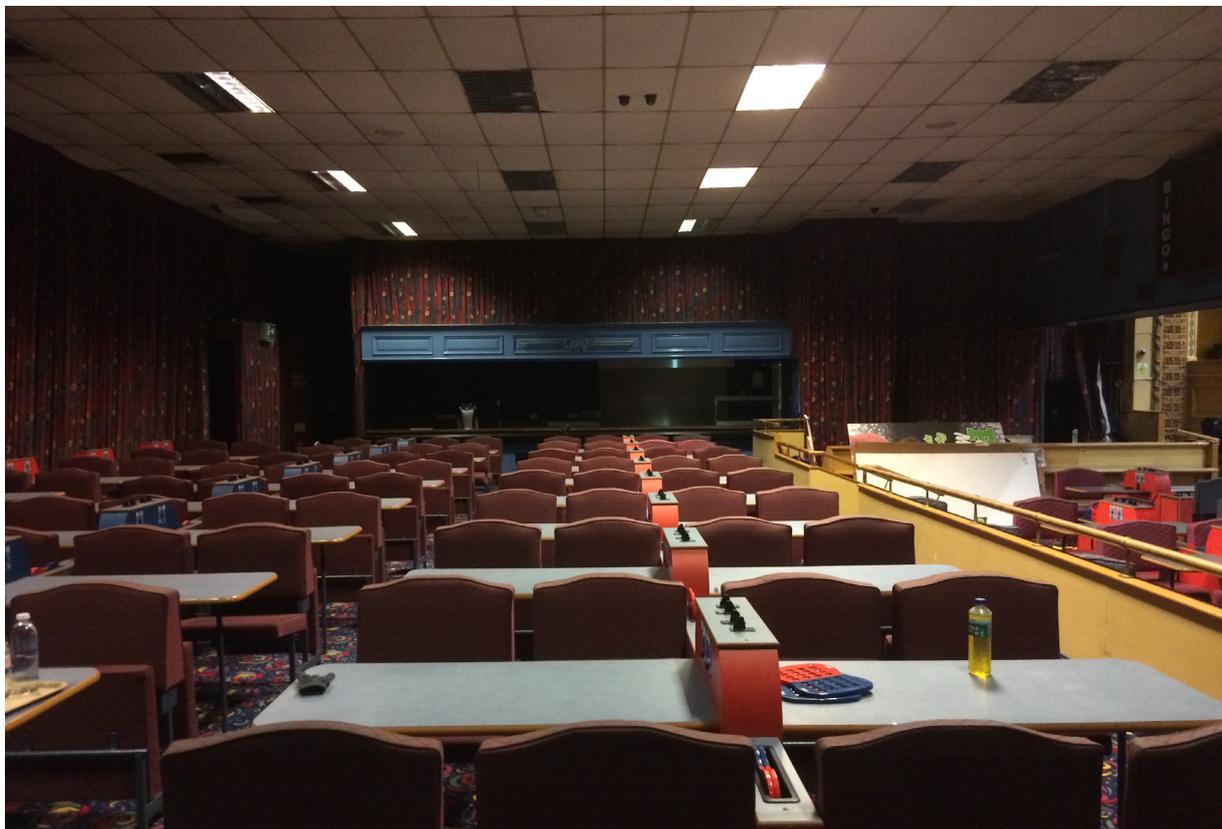
2. Main stage. The area consists of the non functioning bingo hall with a deteriorating suspended ceiling that conceals the full height of the stage. The area is damp with potential water ingress from above.

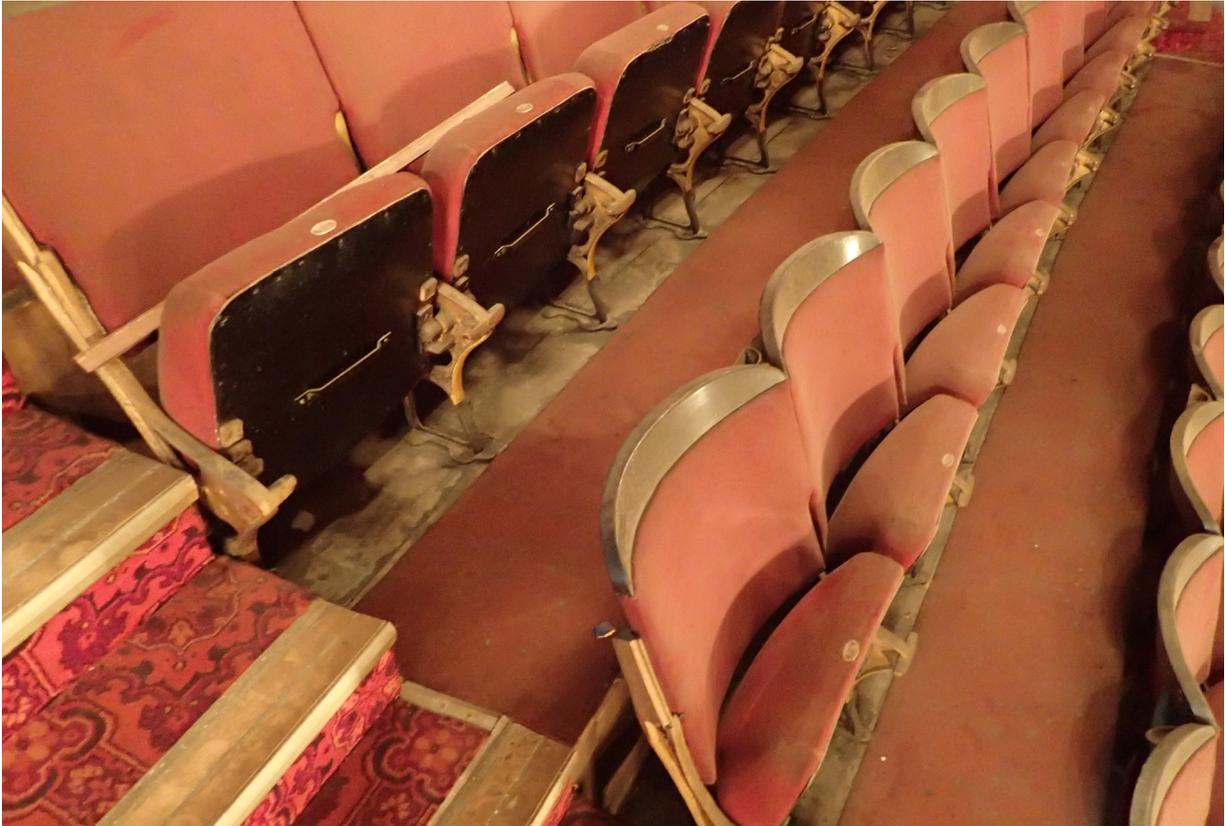
3. Balcony and Circle seating. The original seats are mould infested with rusted mechanisms and fabric deterioration. The flooring is damp with poor conditions to the substrate.

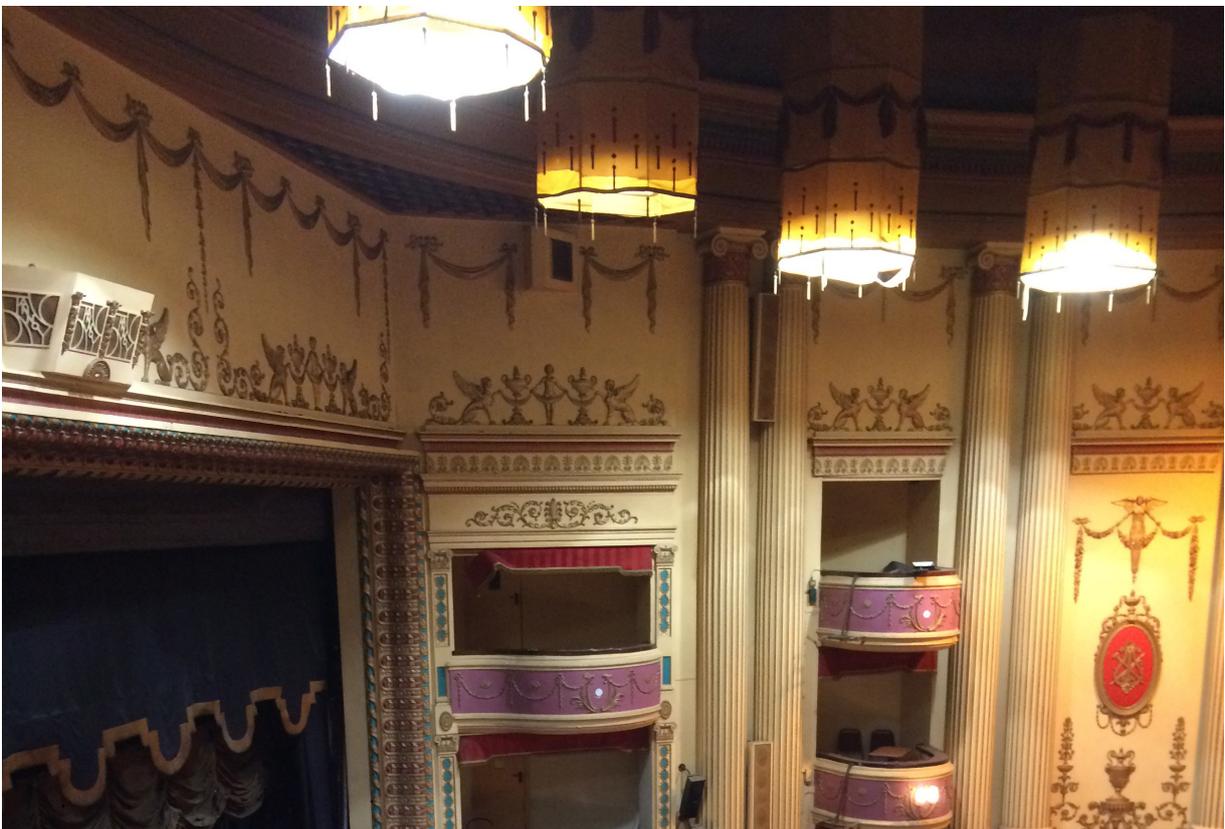
4. Main auditorium ceiling. The decorations, paintwork and lanterns are in poor condition.

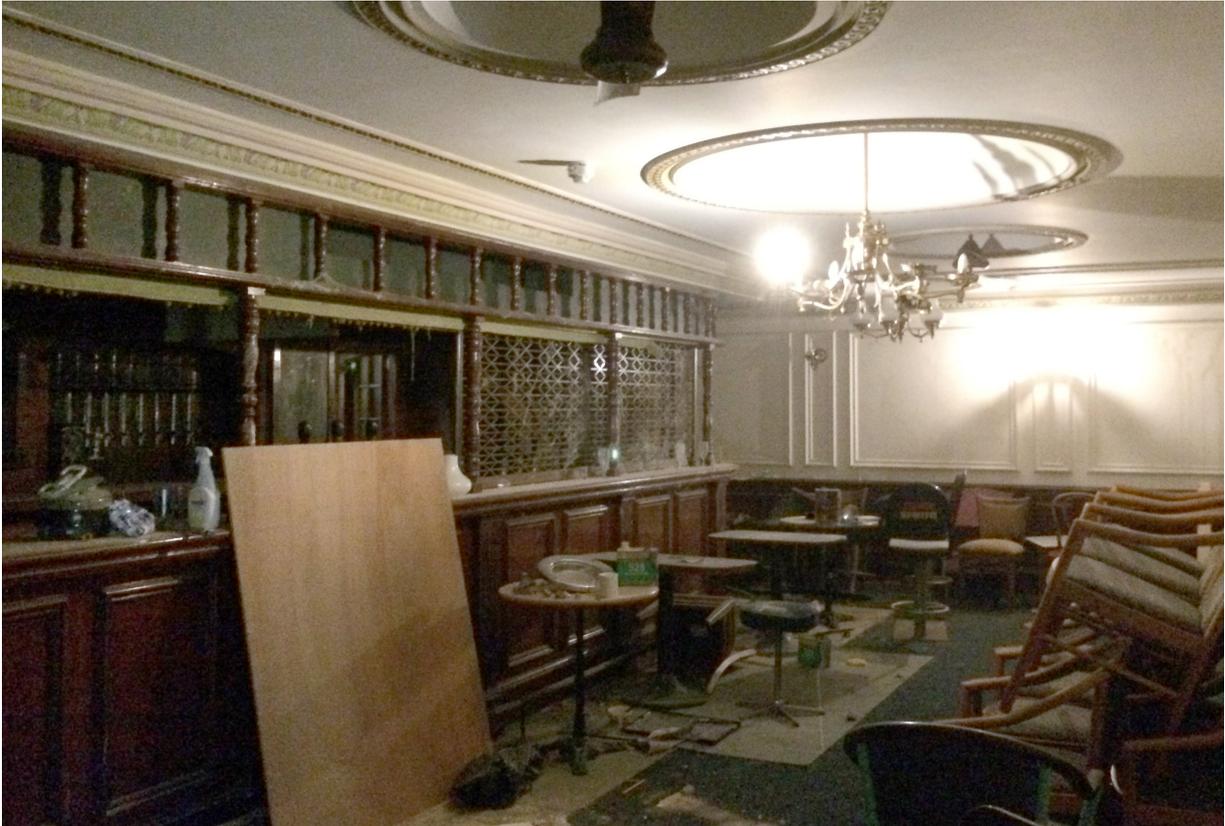
5. Basement Stalls Saloon. The room is in poor condition with rotted timbers to the original bar, peeling plasterwork, broken brickwork to the retaining walls behind the bar, and damp ingress from the flooded portion of the basement.

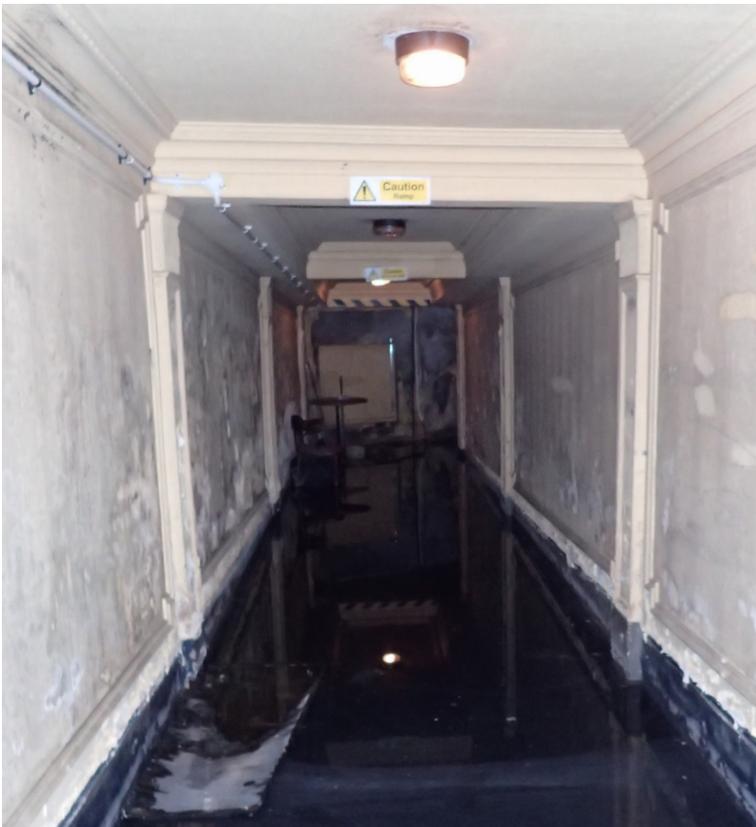
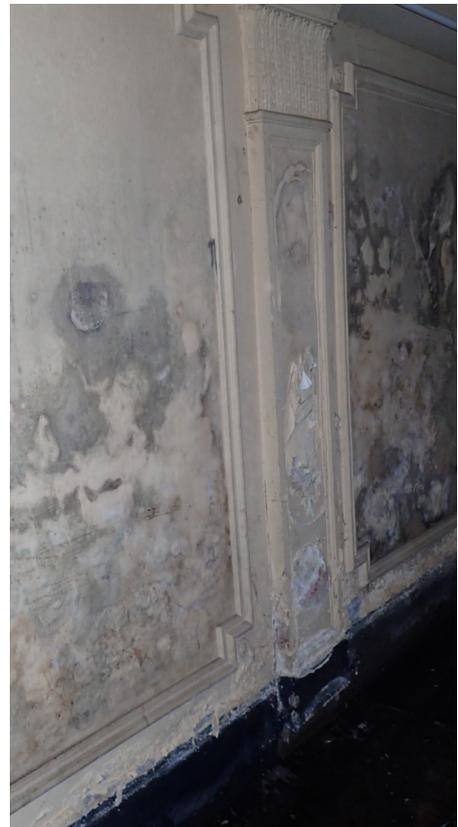
6. Basement Rear. The subway paths that lead up to the ground floor are flooded with water ingress from below ground. The walls with original plasterwork are deteriorating. The flooding is the likely cause of the damp problems throughout the lower floors of the building.

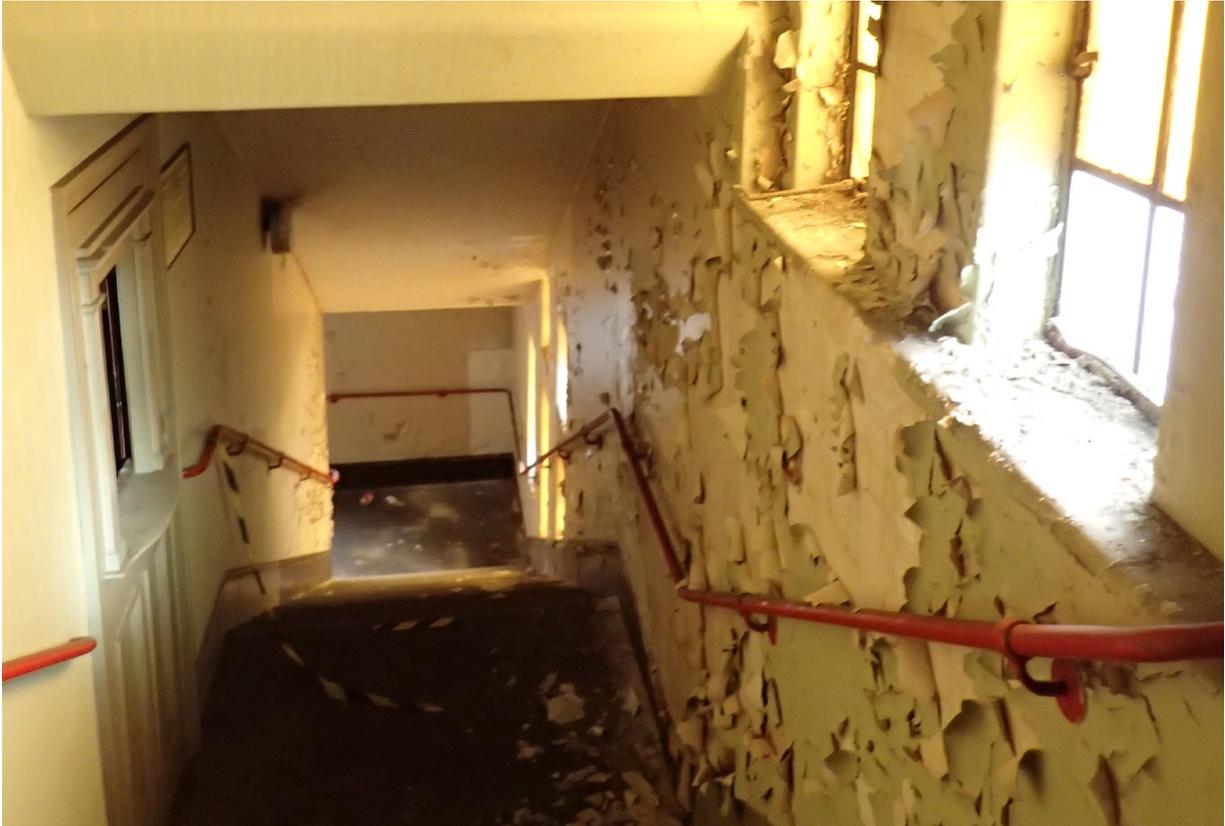
7. Stairs to Balcony and Circle levels. The walls have deteriorated along with the historic crittal windows. There is also water ingress around some of the window frames.

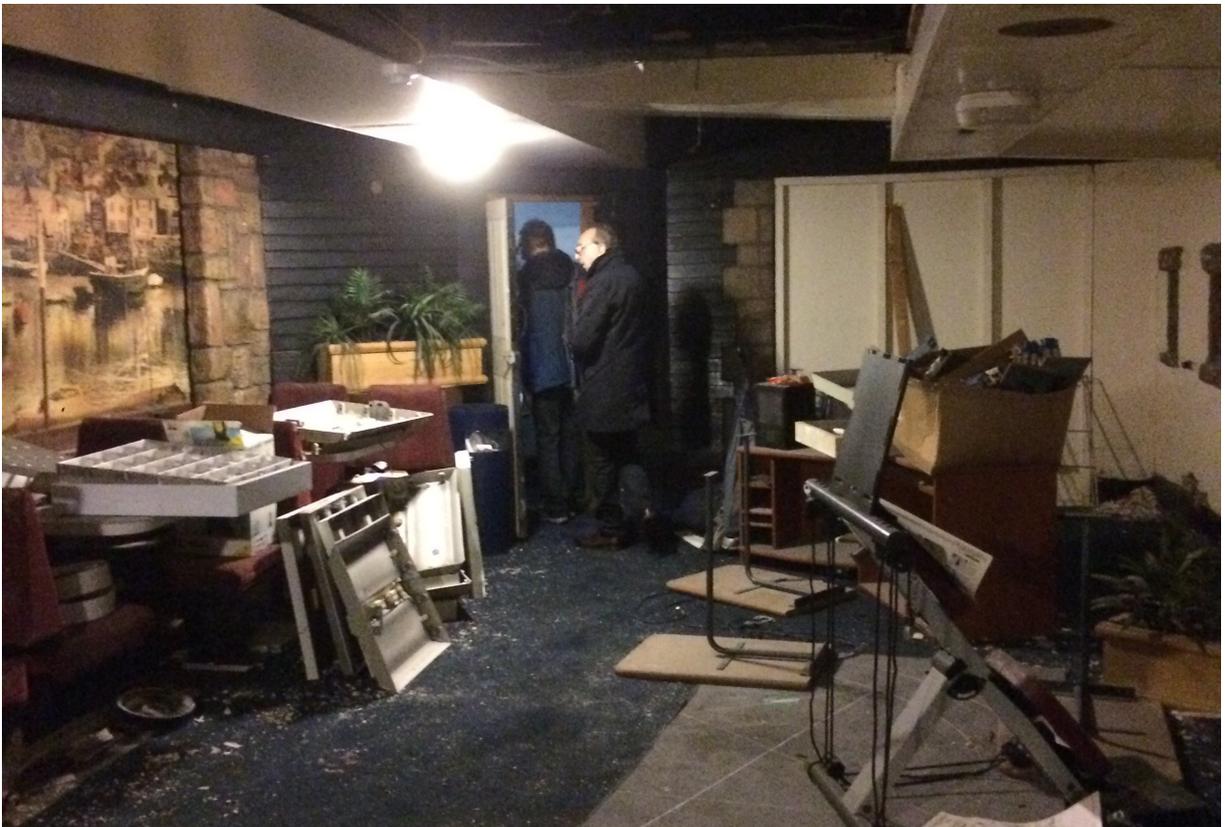
8. Pit Saloon. The room is damp. Mould is evident to the floors, walls and ceilings caused from the flooded area of the basement. The areas are in a state of neglect and some fabric elements are becoming structurally unsafe.

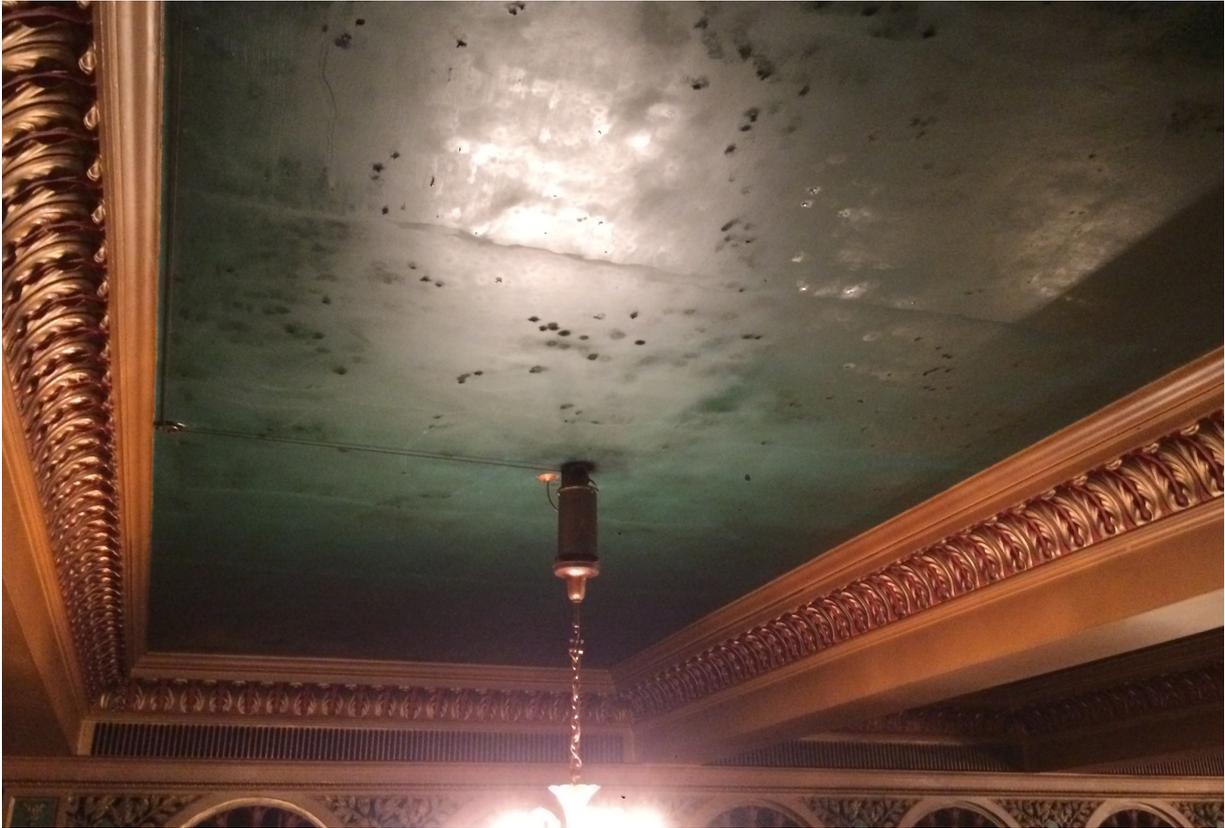
9. Upper Circle. The roof of the auditorium shows the severity of the damp with vast patches of wet plasterwork affecting the integrity of the original ceilings.

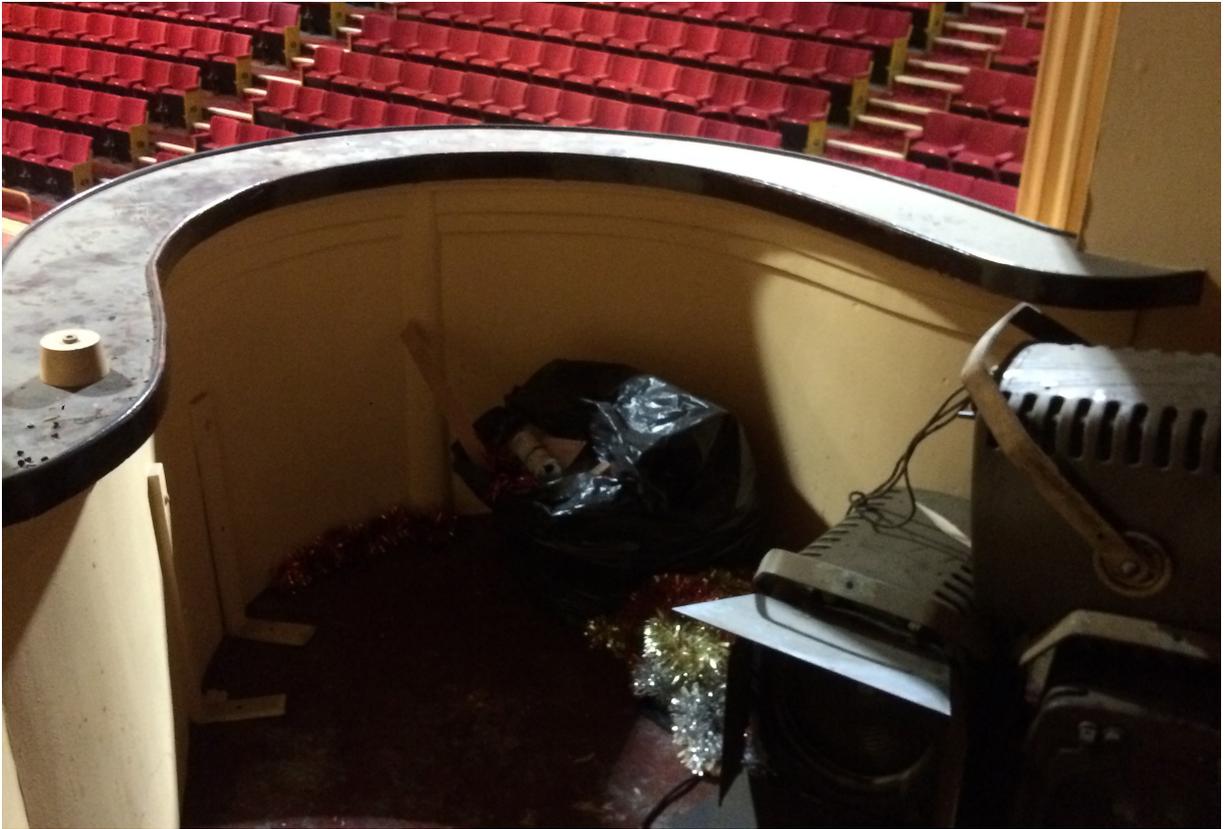
10. Auditorium boxes. Timberwork and flooring is in poor condition. The areas have been neglected and would require significant attention in order to bring them back to functional order.

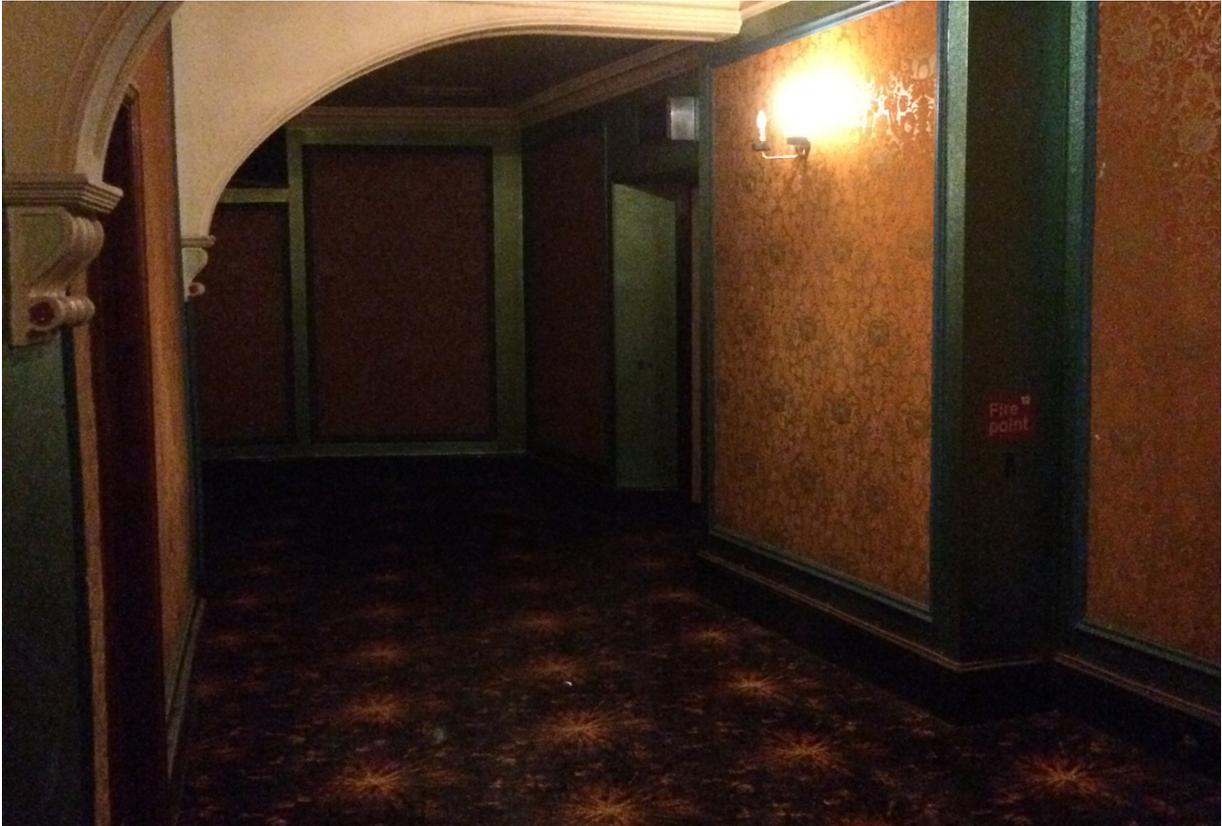
11. Balcony Lounge. The area is damp and in a state of neglect. Electrical circuitry to the area is also in poor condition making the space dark and uninhabitable.

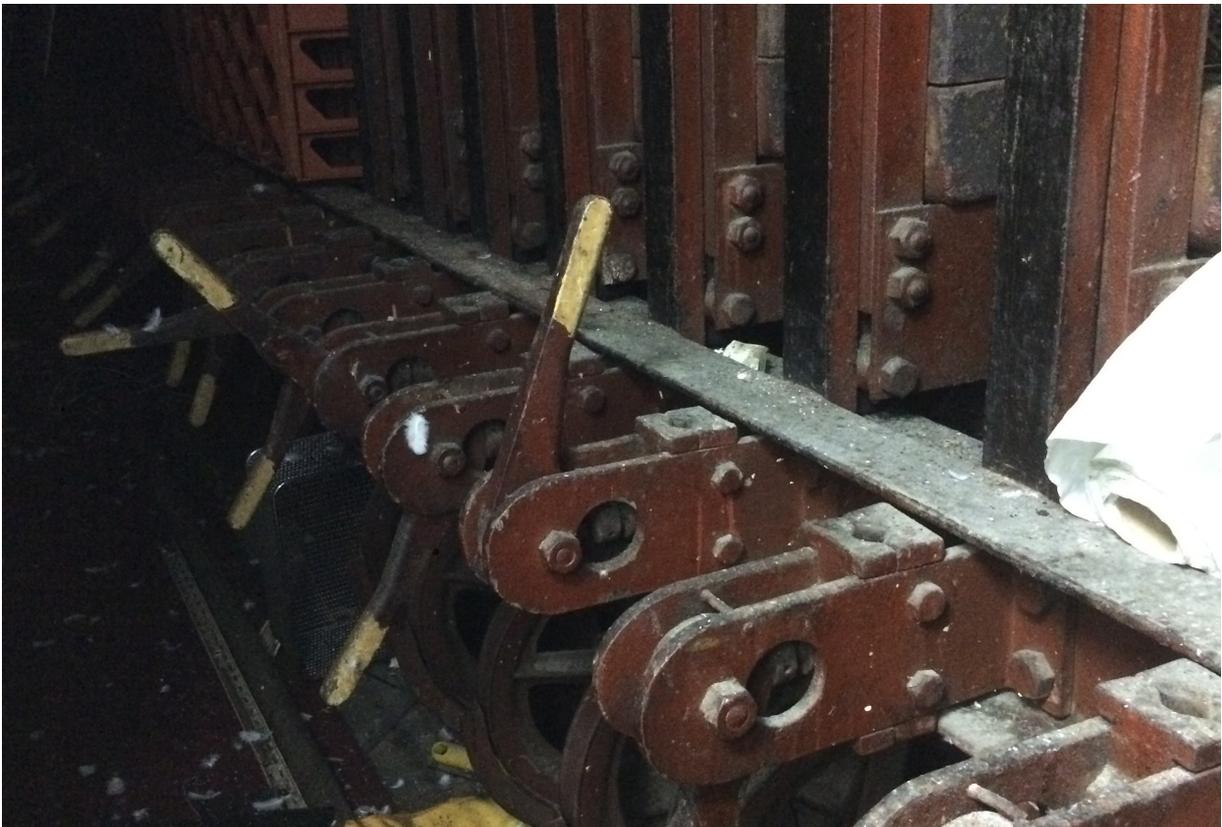
12. Stage fly wheels. The original stage fly wheel mechanisms are still intact but would be at risk of rust and decay due to the current state of damp throughout the building.

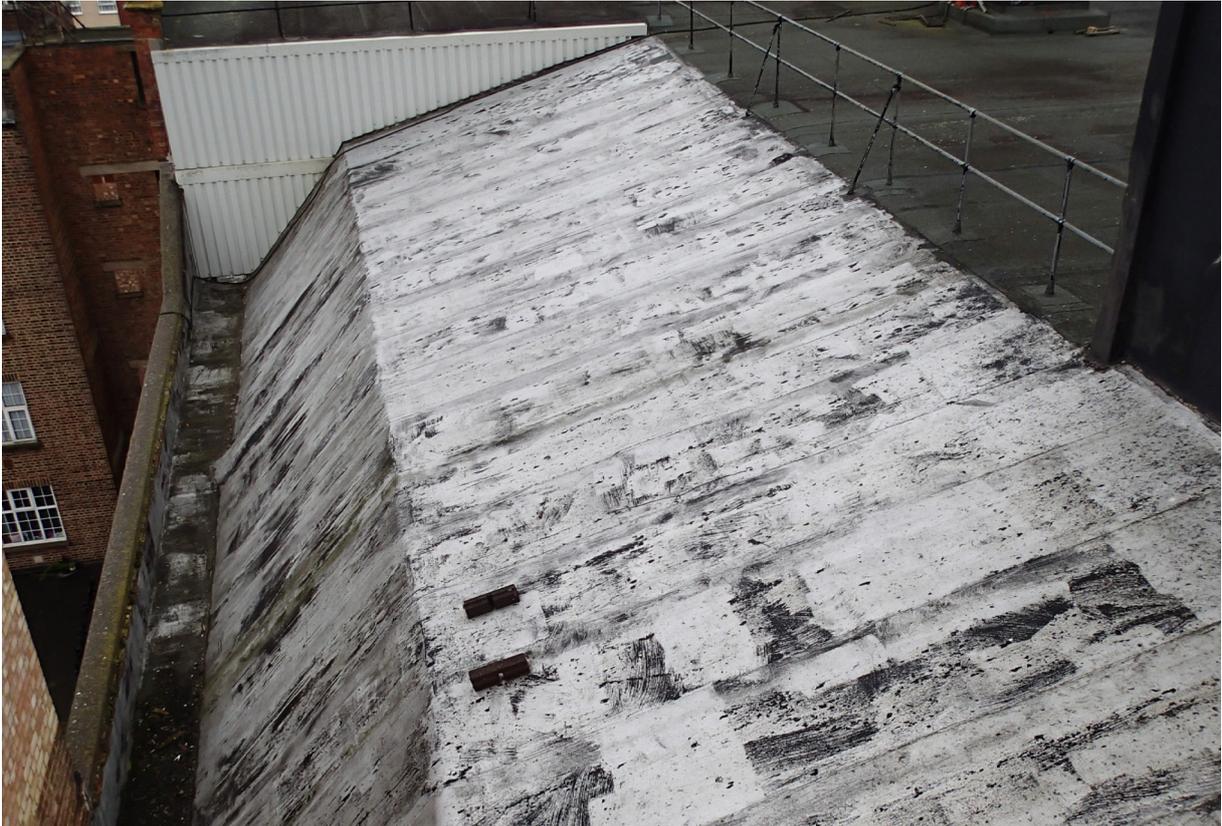
13. Roof level. The roof in areas is in poor condition with ponding occurring and moss buildup within gulleys causing issues to waterproofing. This is causing some water leakage to the internal spaces. There is limited remaining life on of the roof membrane and would need attention in the near future.

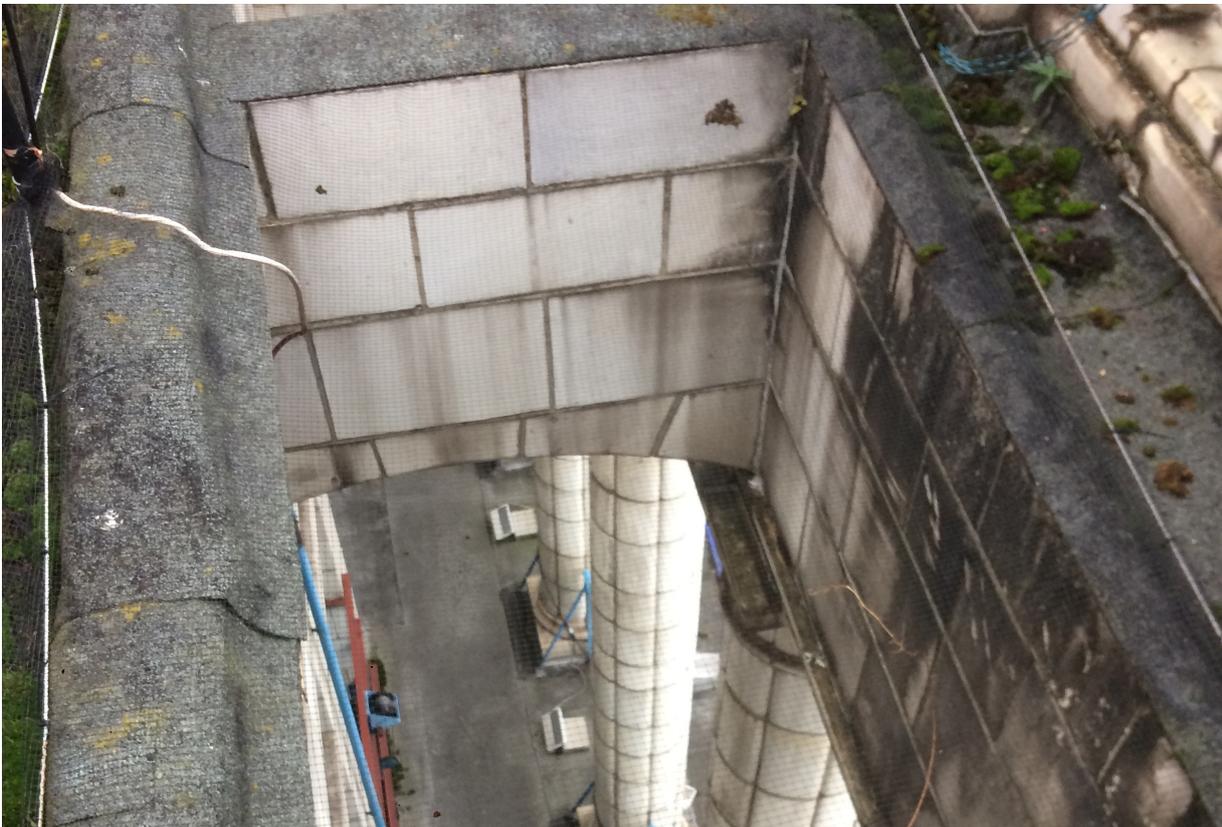
14. Facade: The historic Carraraware tiled facade is deteriorating in various spots, with some tiles having fallen off placing further risk of water ingress through the main walls. Copings have been poorly weathered causing staining along the facade.

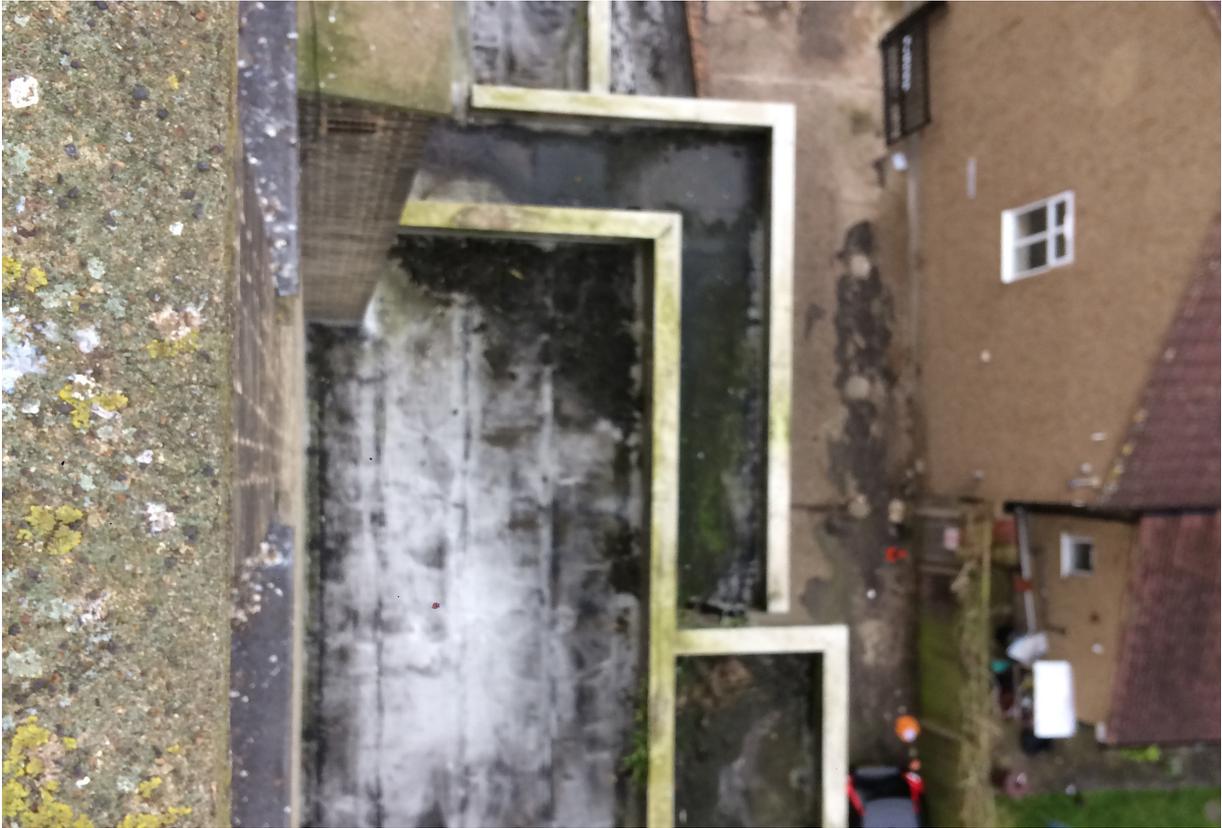
15. Roof levels to south side. Poor condition of roofing membrane with deterioration on flashings and copings.

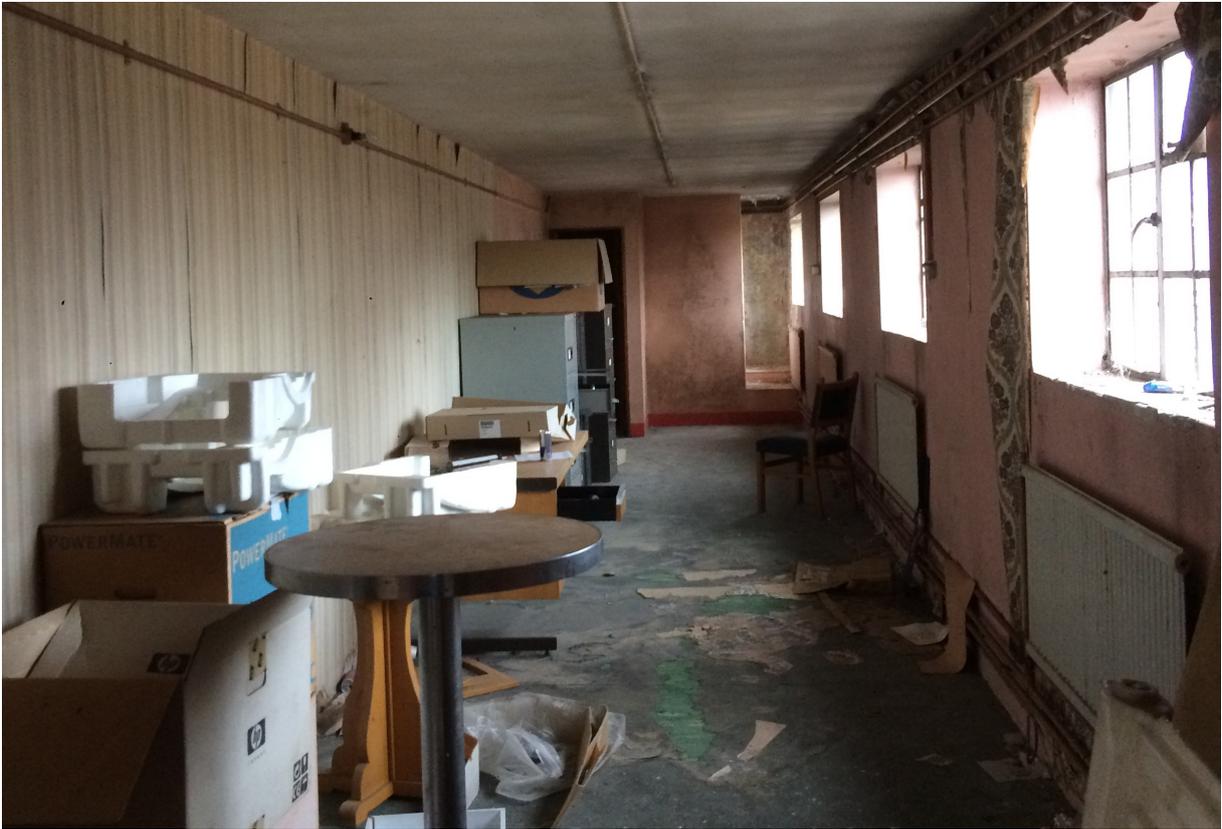
16. Back of house spaces generally. Spaces are generally in a poor state with non functioning heating system, dated electrics, peeling paintwork and damp/mould in various spots.
